Top Reasons Fire Alarm System Installations Fail Inspection

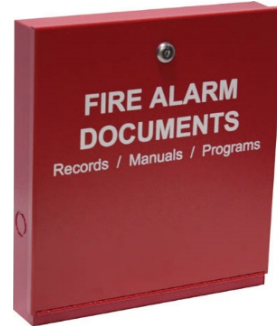
1. A locking Records Retention “Documents Cabinet” – [NFPA 72-7.7.2.1](#)
 - a. Final approved/As-Built Drawings
 - b. SF-035 Contractor Certification
 - c. Written basic system operation instructions including bypass codes
 - d. Spare keys
 - e. Panel software

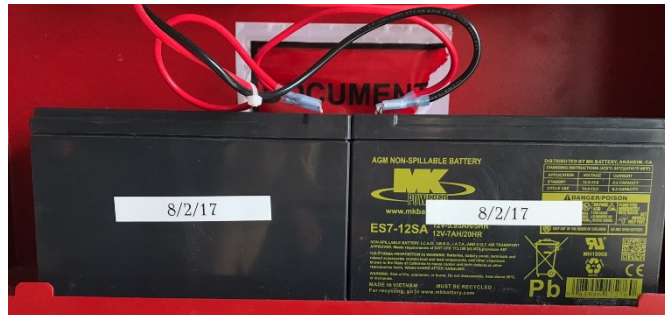
2. Breaker & panel labels with “Red” lockout device – [NFPA 72-10.6.5.2.3](#)
 - a. Battery labeling utilizing a label maker, with contrasting white background & black letters or numbers [NFPA 72-10.6.10.1.1](#)

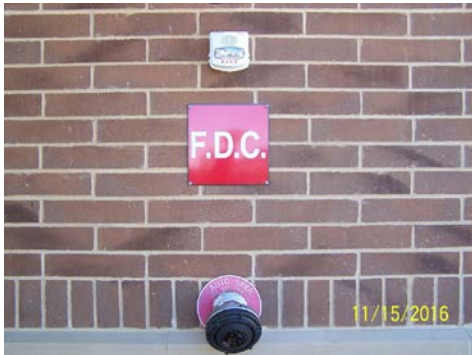
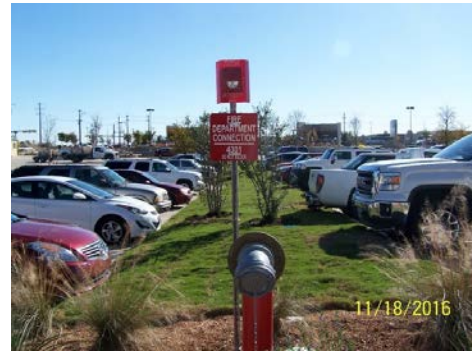
7. Failing to comply with [Prosper Ordinance/Amendments - 907.6.7-Waterflow Notification](#). An exterior audible and visible notification device shall be provided on the exterior of the building above the fire department connection. If a remote FDC is installed, an additional exterior audible and visible notification device shall be located above the FDC seven (7) feet above finished grade

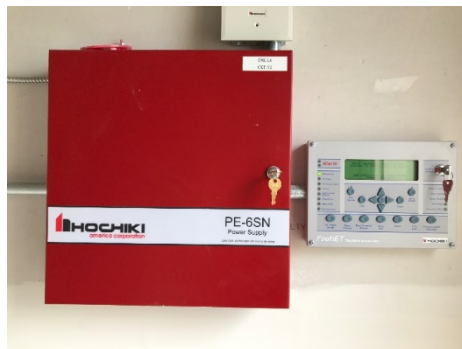
8. Failing to comply with [Prosper Ordinance/Amendments - 907.1.4. Design Standards](#). “Riser rooms shall be equipped with an annunciator panel”. *Exception*, when the fire alarm control panel is installed in the riser room.

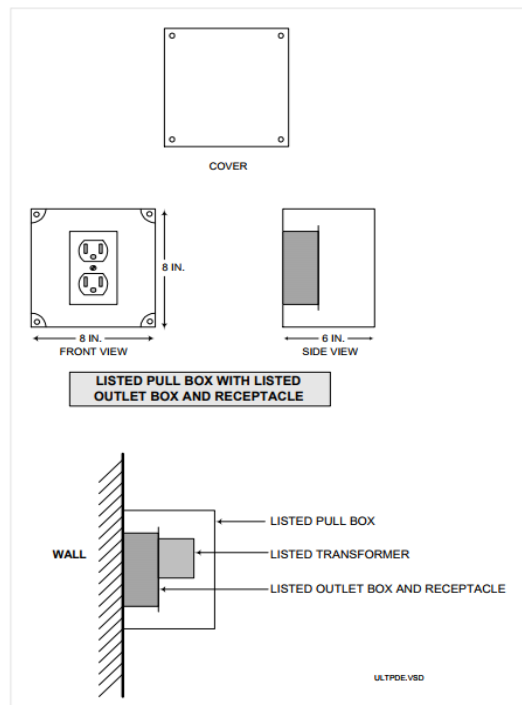
Installation Using Conduit

- a. Wiring from the panel terminals to the A/C transformer to be in a raceway
- b. A tamper cover over the transformer and the dedicated A/C electrical receptacle

REQUIREMENTS			
Requirement	Commercial Fire Sole Path	Commercial Fire Backup	✓
AC transformer lines in flexible conduit.	Required	Required	
AC transformer plugged into un-switched outlet.	Required	Required	
AC transformer plugged into dedicated branch circuit.	Required	Required	
Antenna cable in flexible conduit concealed or covered by motion detector.	Required	Required	
12V battery backup requirement (minimum of 7AH to ensure 24hrs standby + 60 minute transmit).	Required	Required	
AC and battery failure supervision.	Required	Required	
60-minute supervision.	Required	Not Required
