# PROSPER FIRE RESCUE

## FIRE MARSHAL'S OFFICE

## Top Reasons Fire Alarm System Installations Fail Inspection

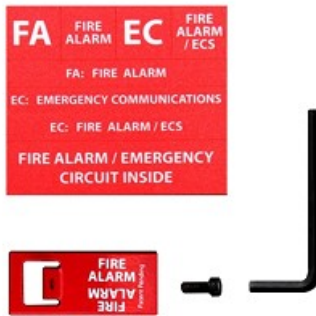
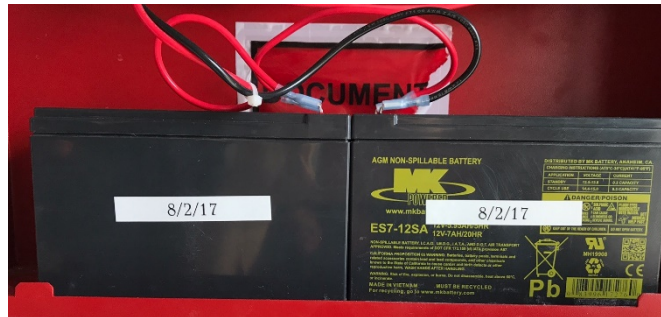
### 2. Breaker & panel labels with “Red” lockout device – [NFPA 72-10.6.5.2.3](#)

- Battery labeling utilizing a label maker, with contrasting white background & black letters or numbers  
[NFPA 72-10.6.10.1.1](#)

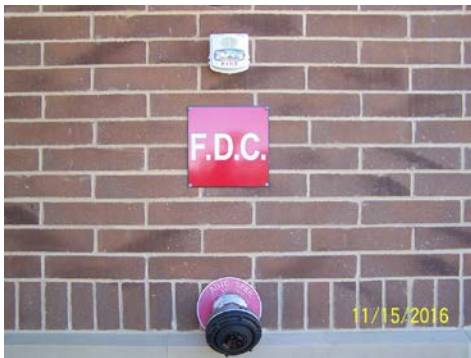
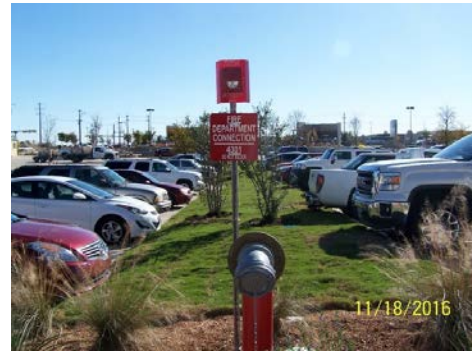
7. Failing to comply with [Prosper Ordinance/Amendments - 907.6.7-Waterflow Notification](#). An exterior audible and visible notification device shall be provided on the exterior of the building above the fire department connection. If a remote FDC is installed, an additional exterior audible and visible notification device shall be located above the FDC seven (7) feet above finished grade

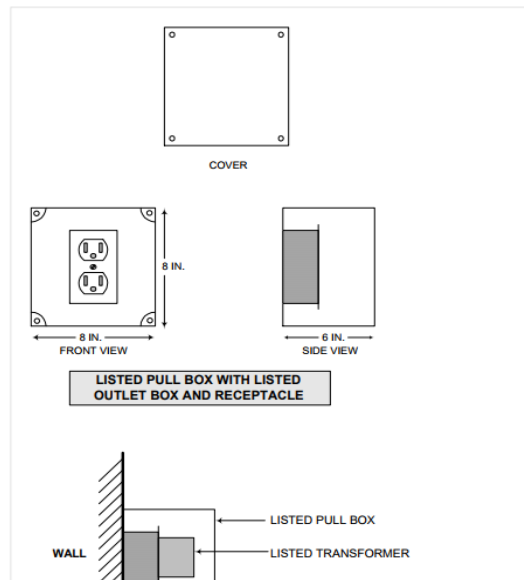
**Installation Using Conduit**

- a. Wiring from the panel terminals to the A/C transformer to be in a raceway
- b. A tamper cover over the transformer and the dedicated A/C electrical receptacle

REQUIREMENTS			
Requirement	Commercial Fire Sole Path	Commercial Fire Backup	✓
AC transformer lines in flexible conduit.	Required	Required	
AC transformer plugged into un-switched outlet.	Required	Required	
AC transformer plugged into dedicated branch circuit.	Required	Required	
Antenna cable in flexible conduit concealed or covered by motion detector.	Required	Required	
12V battery backup requirement (minimum of 7AH to ensure 24hrs standby + 60 minute transmit).	Required	Required	
AC and battery failure supervision.	Required	Required	
60-minute supervision.	Required	Not Required
