PROSPER FIRE RESCUE

FIRE MARSHAL'S OFFICE

Top Reasons Fire Alarm System Installations Fail Inspection

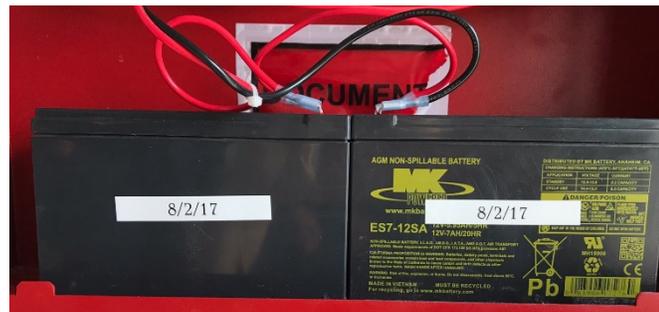
2. Breaker & panel labels with “Red” lockout device – [NFPA 72-10.6.5.2.3](#)

- a. Battery labeling utilizing a label maker, with contrasting white background & black letters or numbers [NFPA 72-10.6.10.1.1](#)

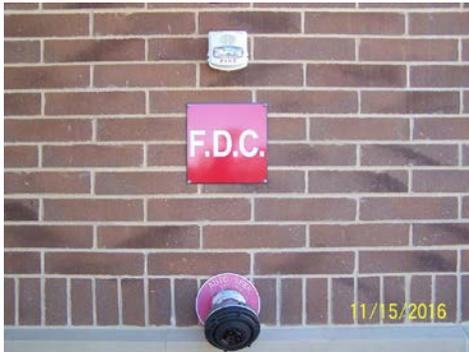
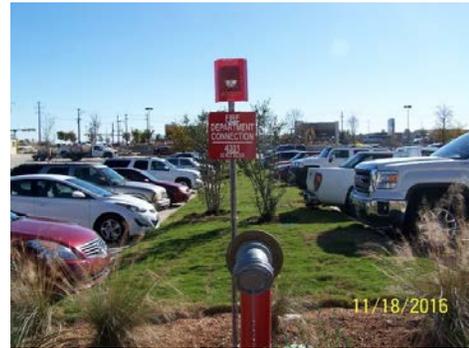
7. Failing to comply with [Prosper Ordinance/Amendments - 907.6.7-Waterflow Notification](#). An exterior audible and visible notification device shall be provided on the exterior of the building above the fire department connection. If a remote FDC is installed, an additional exterior audible and visible notification device shall be located above the FDC seven (7) feet above finished grade

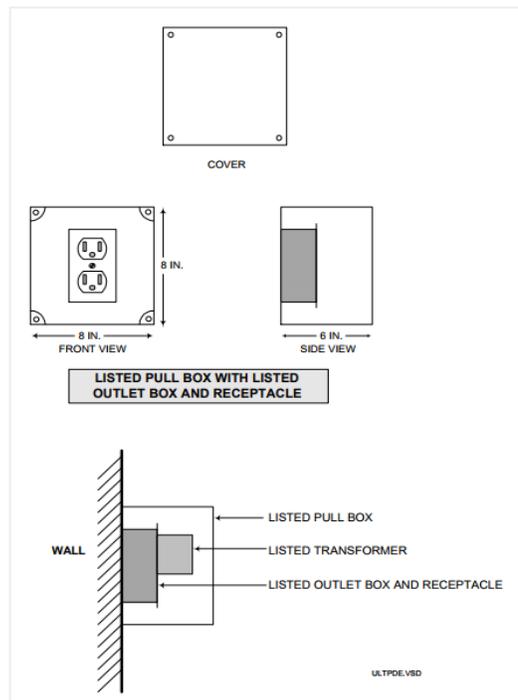
Installation Using Conduit

REQUIREMENTS			
Requirement	Commercial Fire Sole Path	Commercial Fire Backup	✓
AC transformer lines in flexible conduit.	Required	Required	
AC transformer plugged into un-switched outlet.	Required	Required	
AC transformer plugged into dedicated branch circuit.	Required	Required	
Antenna cable in flexible conduit concealed or covered by motion detector.	Required	Required	
12V battery backup requirement (minimum of 7AH to ensure 24hrs standby + 60 minute transmit).	Required	Required	
AC and battery failure supervision.	Required	Required	
60-minute supervision.	Required	Not Required
