Top Reasons Sprinkler System Installations Fail Inspection

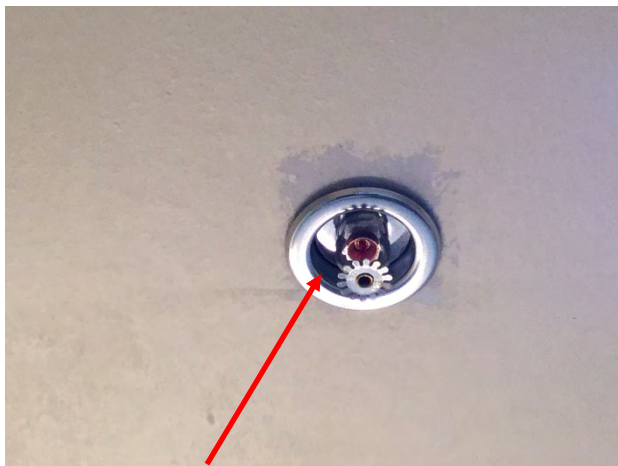
Semi-recessed head with less than 1/2" clearance below the ceiling surface

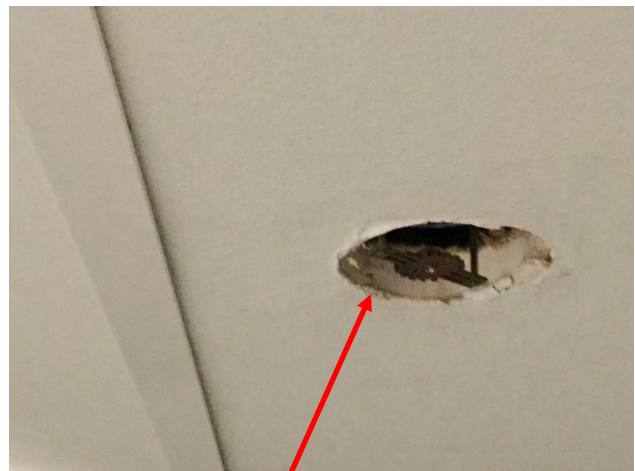
Concealed head with no clearance below the ceiling surface

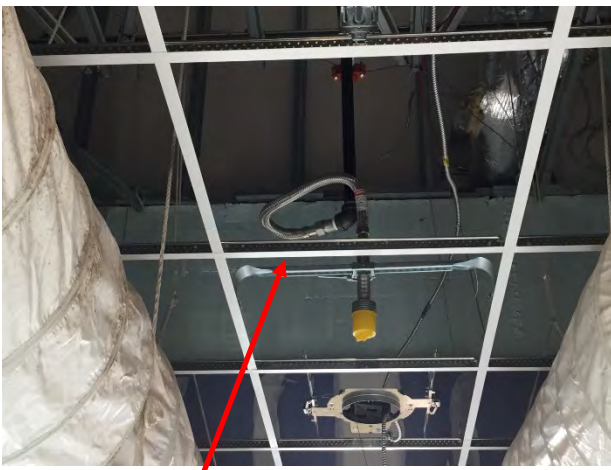
* UL: 4" minimum bend radius, where C=120

Failing to maintain the 4" minimum radius & number of bends allowed for 2' hose in violation of the U. L. Listing

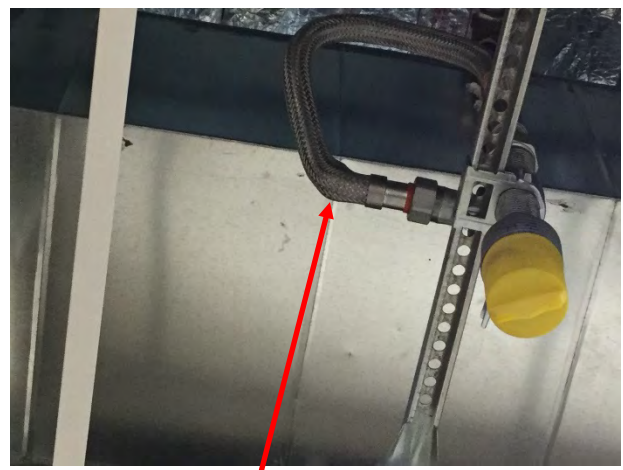
Crimped the hose during installation to achieve center tile

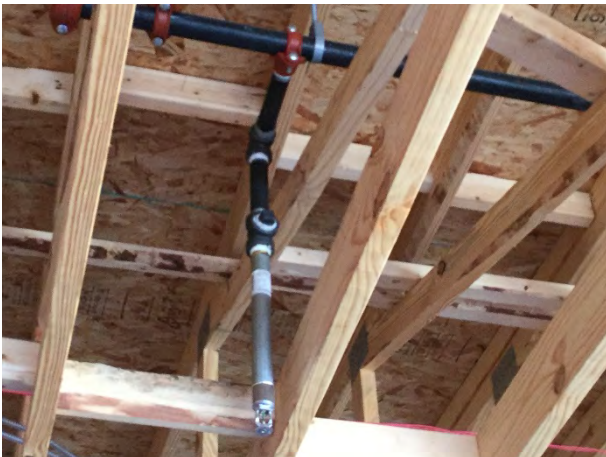
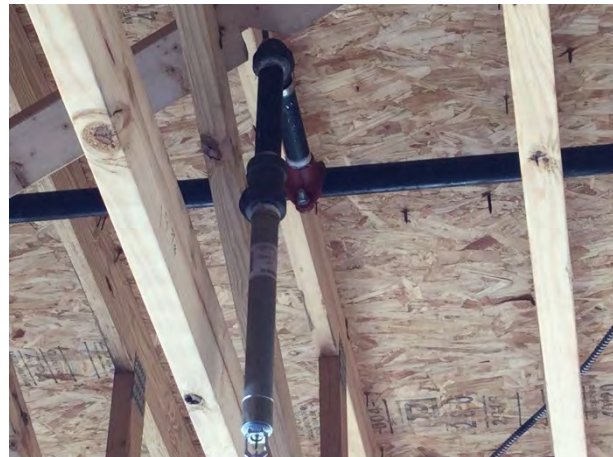
3. Failing to comply with the proper installation of dry pendent heads [NFPA 13-15.3](#). This environment was a non-climate controlled, non-insulated concealed space.

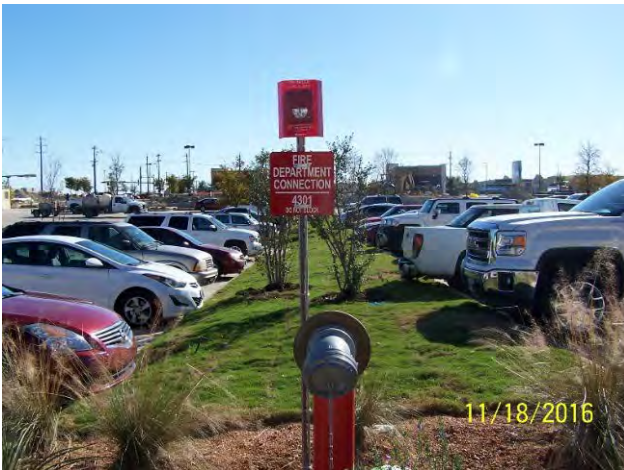
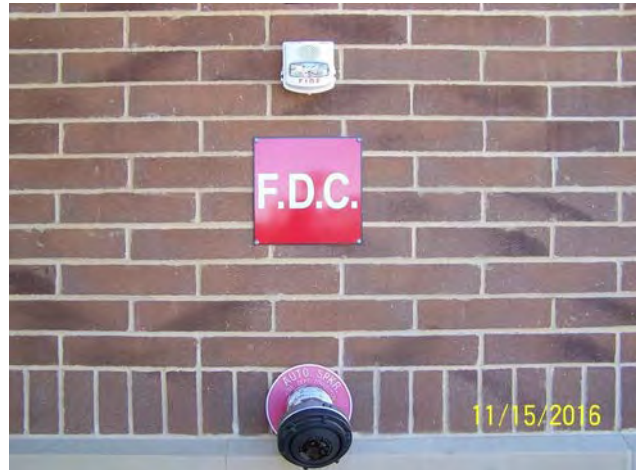
4. Failing to comply with Ordinance/Amendments - 511.4 Fire Department Connection shall be a 5 inch (5") Storz connection with a 30 degree downward turn, and locking cap. One Storz key shall be furnished to the Fire Department for new installations.
